**PHASE I
ENVIRONMENTAL
SITE ASSESSMENT**

**Arrow Gear Company
2301 Curtiss Street & 5240 Belmont Road
Downers Grove, Illinois 60515**

**Prepared by:
NORTHWEST ENVIROCON, INC.
1000 Jorie Boulevard Suite 20
Oak Brook, Illinois 60521
(708) 574-0560**

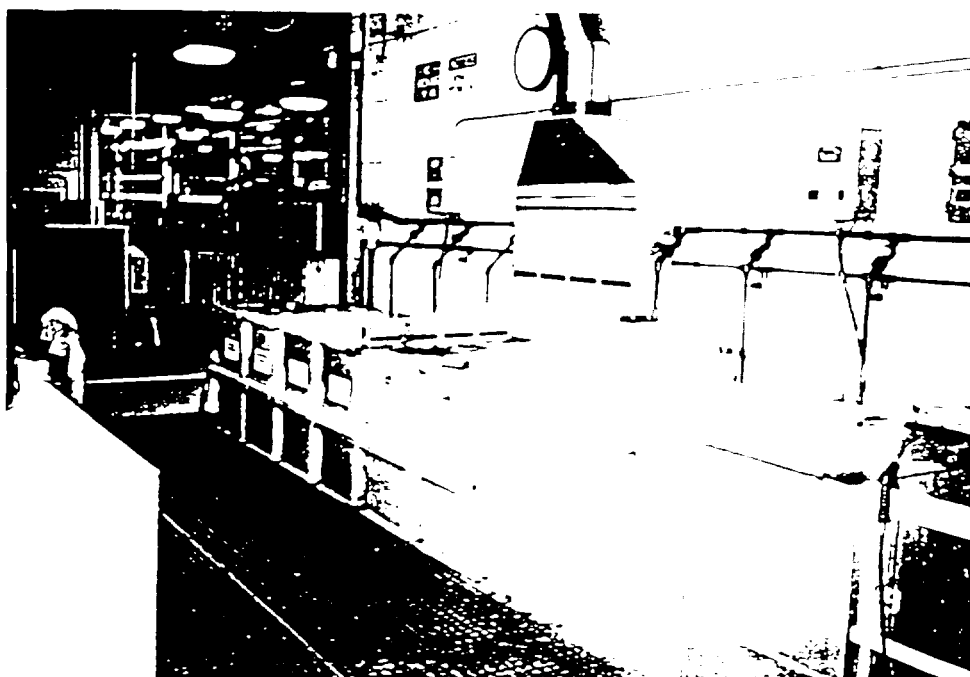
Several plastic containers and steel drums of chemicals were observed to be stored in an area at 2301 Curtiss Street used for product cleansing. The containers rested on a raised steel grated floor. Beneath the steel grated floor was a spill retainage system constructed of an approximately 1' high poured concrete floor. According to Mr. Kauzlarich, this area does not contain a drain for obvious purposes. Chemicals in this area included: sodium hydroxide neutralizer, hydrochloric acid, nitric acid, ammonia, acid, ethyl glycol (anti-freeze), chemical spill cleanup absorbent, and copper stripper. Evidence of a previous drainage system was observed on the corners of the retainage area.

Photo #5: Material storage in 2301 Curtiss Street. Previous location of trichlorethylene

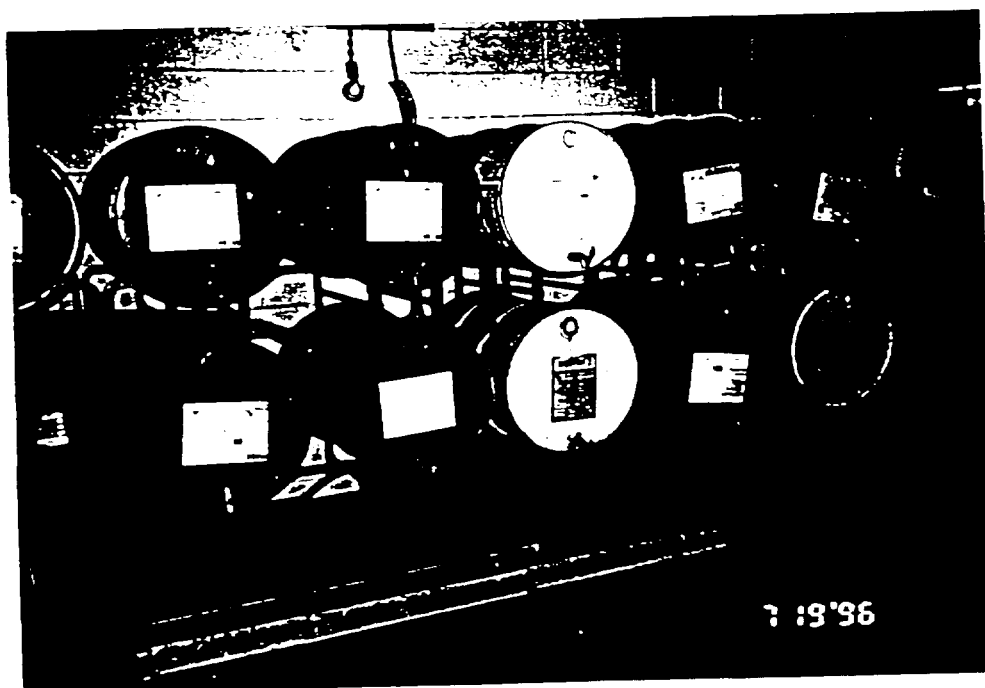
Approximately fourteen fifty-five gallon drums were observed in the loading dock area including the storage of such chemicals as methanol and magnaflux. The drums were lied on their sides and doubled up on a rack next to a wall. The drums are currently in use as the Assessor observed tappers on each drum indicating easy and quick access. Bins were observed beneath the tappers and appeared to catch excess material dripping from the drums. Heavy staining was observed beneath the drums. According to Mr. Kauzlarich, the wall behind the drums is non-load bearing. Better housekeeping practices should be implemented to ensure further staining is kept to a minimum.

Photo #6: Material storage next to loading dock

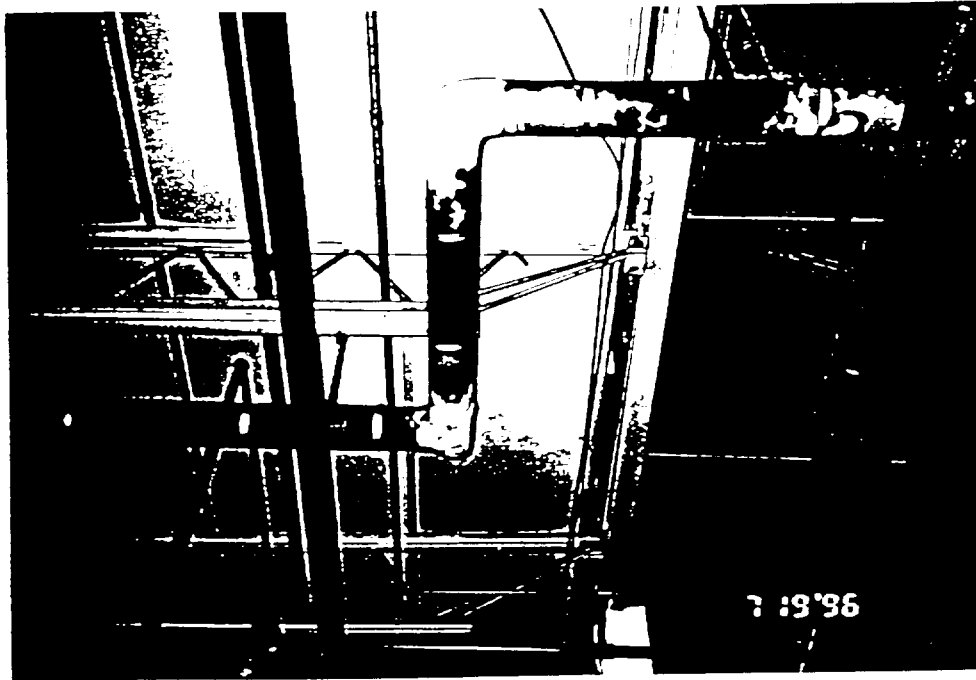
During the on-site inspection materials were observed including but not limited to: drywall, ceiling tiles, floor tiles and roofing materials. As defined in NESHAP §61.141 the observed materials may be classified as suspect regulated asbestos-containing materials. Prior to demolition, renovation, or any other activity that could disturb these materials either an inspection should be performed by an accredited Building Inspector or the materials should be handled as asbestos-containing.

Photo #7: Suspect ACM pipe fittings

- **Suspect Asbestos-Containing Materials:** During the on-site inspection materials were observed, including but not limited to: drywall, ceiling tile, floor tile, thermal system insulation fittings and roofing materials. As defined in NESHAP 61.141, the observed materials may be classified as suspect asbestos-containing materials. Prior to demolition, renovation, or any other activity that could disturb these materials either an inspection should be performed by an accredited Building Inspector or the materials should be handled as asbestos-containing.

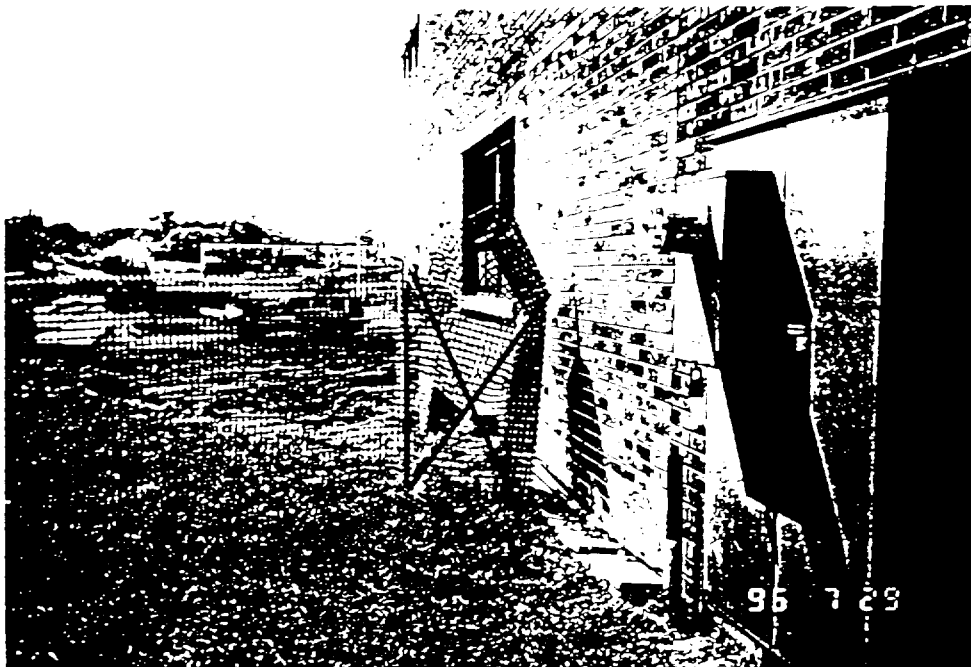
During the on-site investigation two pipes were observed on the southwestern corner of the building. An obvious petroleum aroma was detected from one of the pipes. These pipes are characteristic of a vent and fill pipe for an underground storage tank. During an additional visit performed on August 20, 1996, it was concluded that this area did not contain an underground storage tank. The larger of the pipes was used for a natural gas line feed and the smaller second pipe was used for electrical conduit.

Photo #8: Suspect UST location on southwest corner of building. Note vent and fill pipes

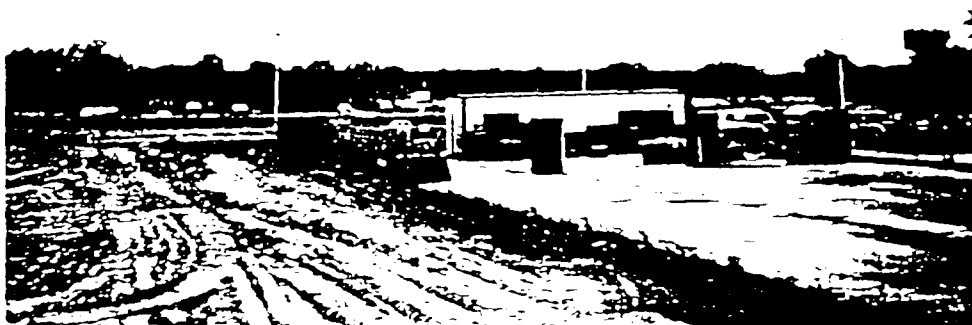
Several dozen steel fifty-five gallon drums were observed on the exterior western side of both buildings on the subject Property. An area was set aside for full drums as well as empty drums. The drums were unable to be closely observed, as they were fenced off. An ammonia-type aroma was detected surrounding this material storage area. Material storage should be housed in the interior of the building.

Photo #9: Exterior storage on western side of building.
